2004 BRIDGE INSPECTION

APALACHICOLA NATIONAL FOREST
BRIDGE NO. 115-02.5
RIVER STYX BRANCH

2004 USFS BRIDGE INSPECTION
APALACHICOLA NATIONAL FOREST
BRIDGE NO. 115-02.5
RIVER STYX BRANCH

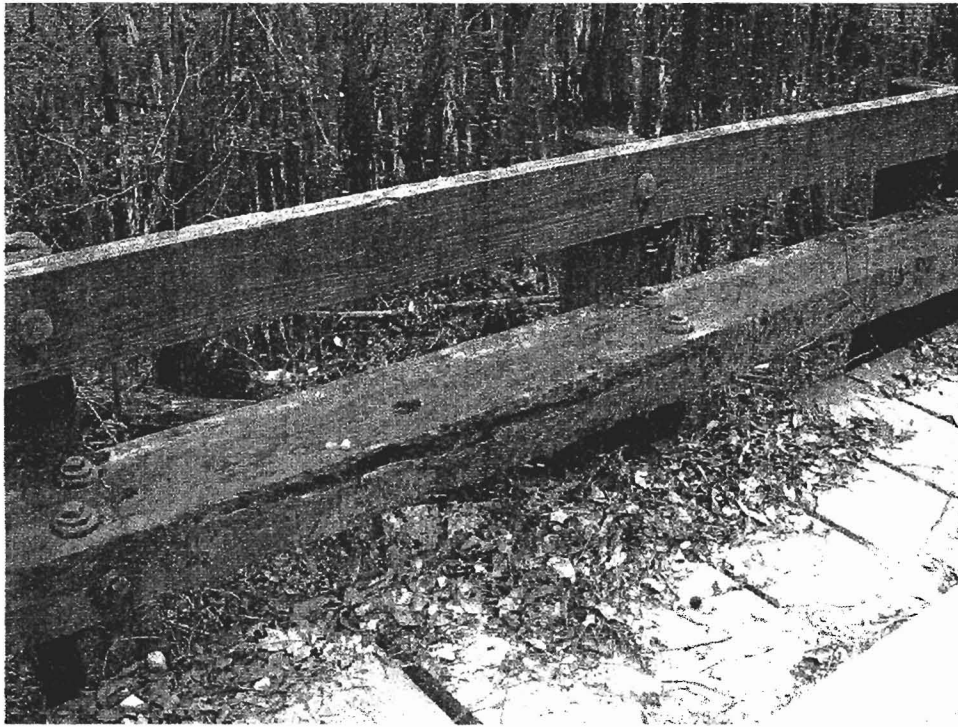
1. The timber rails, posts, and curbs all have areas of severe decay (see Photo 7).
2. Several timber stringers have areas of decay at the bearing areas (see Photos 8 and 9). Stringer 9 in Spans 1 and 2 has areas of decay along the full length (see Photo 10).

Photo 7 – South Curb in Span 3.

58.5- East end of north timber curb has severe decay for a 10' length with 3" pick penetrations. Both curbs have random checks and moss. South curb has a 4' long area of severe decay at Span 3 with 3" pick penetrations.

1. Replace the bridge. Traffic safety upgrades such as approach guardrails should be included with this project.

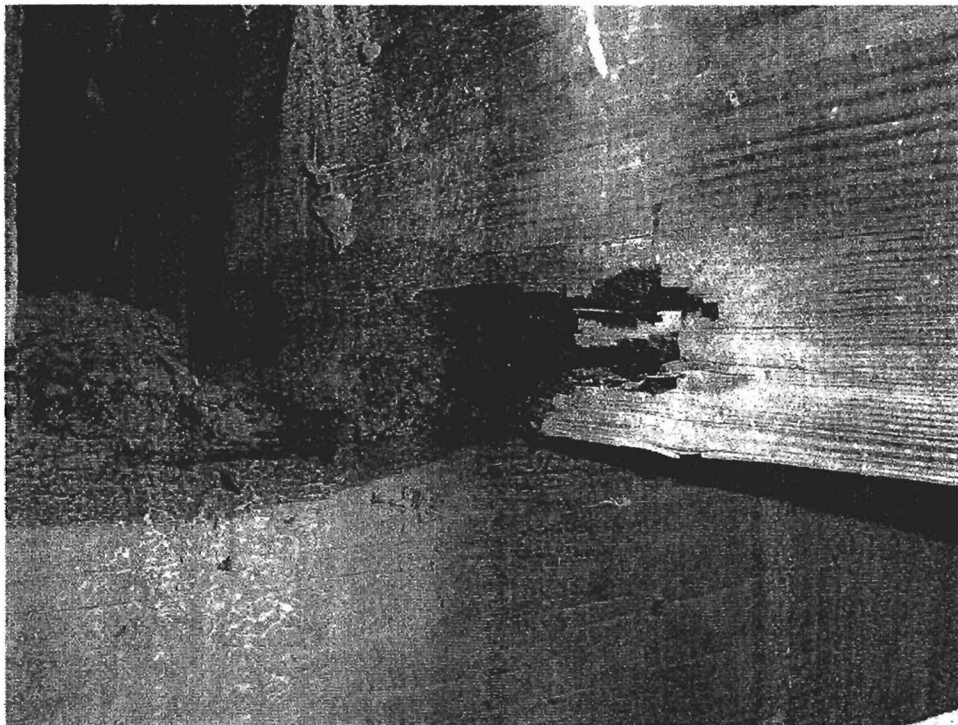
Photo 8 – Stringer 5 in Span 2 at Bent 1.

Stringers 2, 4, 5 and 6 in Span 2 are rotten at the ends over Bent 1. Stringer 5 has 1 1/2" pick penetrations in the bottom and sides at Bent 1. Stringer 4 has 4" deep decay for the full width of the bottom at Bent 1. The bottom of Stringers 4 and 5 are decayed at Bent 2.

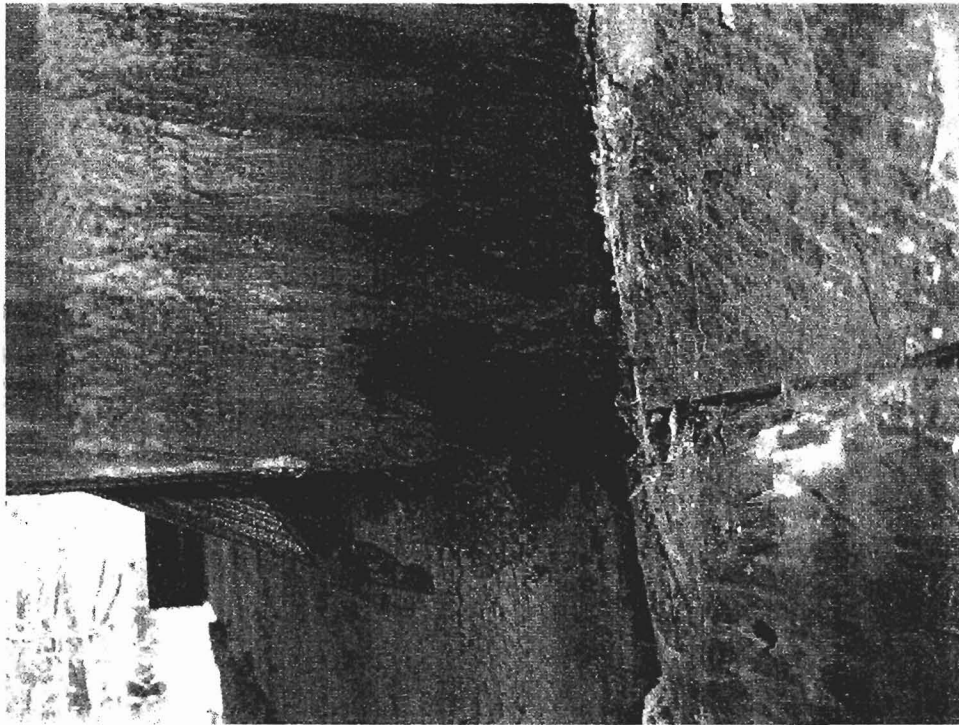
Photo 9 – Stringer 4 in Span 2 at Bent 1.

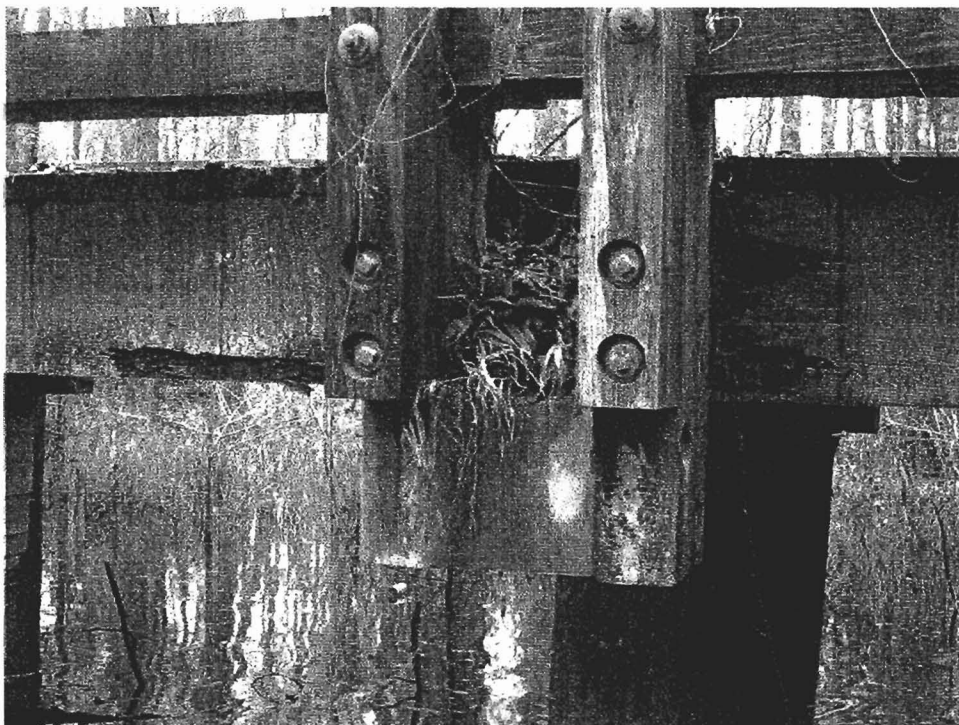
Photo 10 – Stringer 9 at Bent 1.

59.2- Timber stringers have minor splintering at bottom edges at random locations. Stringer 6 in Span 1 decayed at the West Abutment bearing. Stringer 9 in Spans 1 and 2 has areas of decay for the full length.

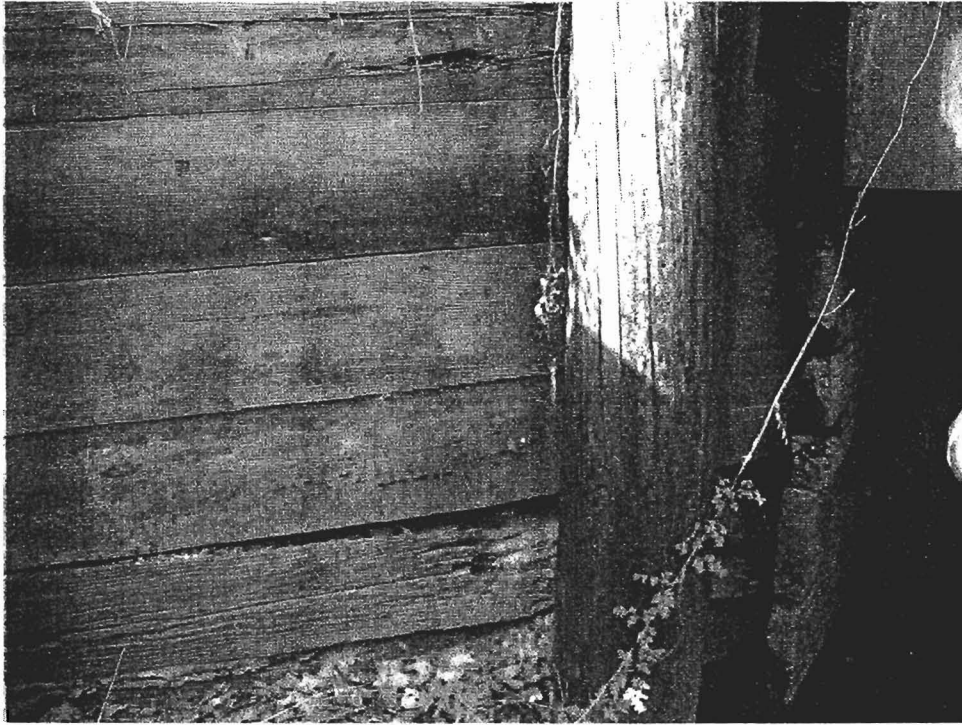
3. The timber sheeting at the Northwest, Northeast and Southwest Wingwalls has heavy decay with loss of fill (see Photo 11). The outer timber piles at the Northwest and Southwest Wingwalls are completely rotten.

4. The bottom timber sheeting board at the both abutments has severe decay with loss of fill. All abutment sheeting was decayed at the ends (see Photo 11).

Photo 11 – Decayed Sheeting in the Southwest Wingwall and at the South End of the West Abutment. Note Loss of Fill.

60.2- The outer timber pile at the Northwest Wingwall is completely rotten. The timber sheeting also has heavy decay with loss of fill. The sheeting at the Northeast Wingwall has heavy decay with loss of fill. The outer pile at the Southwest Wingwall is completely rotten and the sheeting has heavy decay with loss of fill.

60.4- Bottom timber sheeting board at the both abutments has severe decay throughout with loss of fill. Sheeting at both abutments has severe decay at ends.

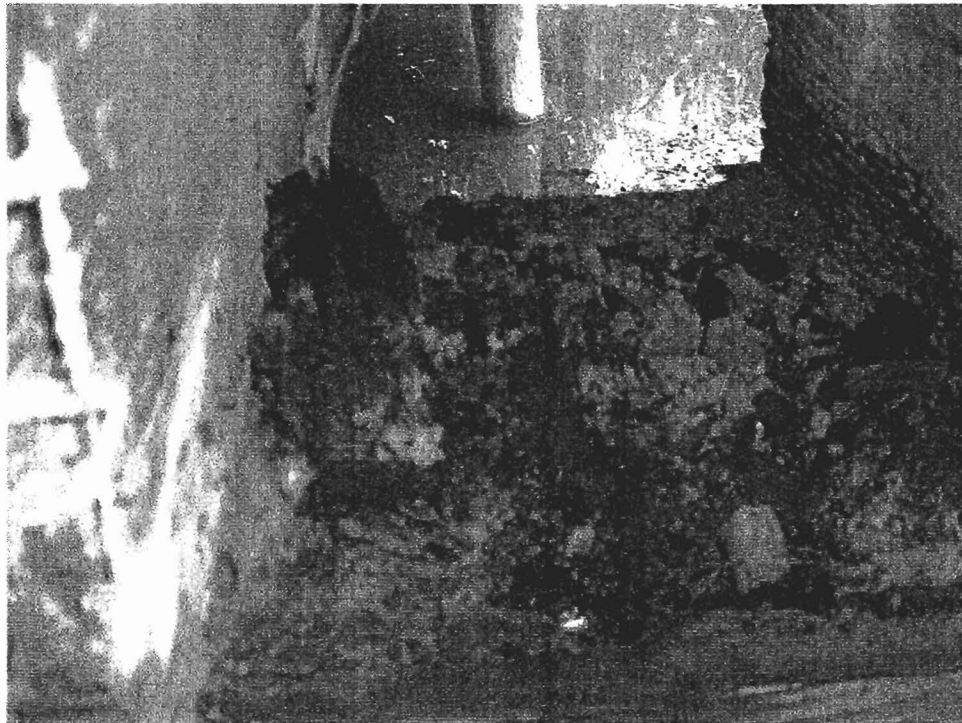
5. The top of Bent Cap 1 is decayed up to 3" deep for the full length (see Photo 12). The top of Bent Cap 2 is decayed up to 2½" deep between Stringers 4 and 5. Bent Cap 2 also has a 6" high x 10" long 3½" deep area of decay at the top of the west face between Stringers 5 and 6 (see Photo 13).

Photo 12 – Top of Bent Cap 1 Between Stringers 7 and 8.

60.4 and 11- All timber bent caps are soft at the surface and have heavy debris on top. The top of Bent Cap 1 is decayed up to 3" deep for the full length. The top of Bent Cap 2 is decayed up to 2 1/2" between Stringers 4 and 5. Bent Cap 2 has a 6" high x 10" long x 3 1/2" deep area of decay at the top of the west face between Stringers 5 and 6.

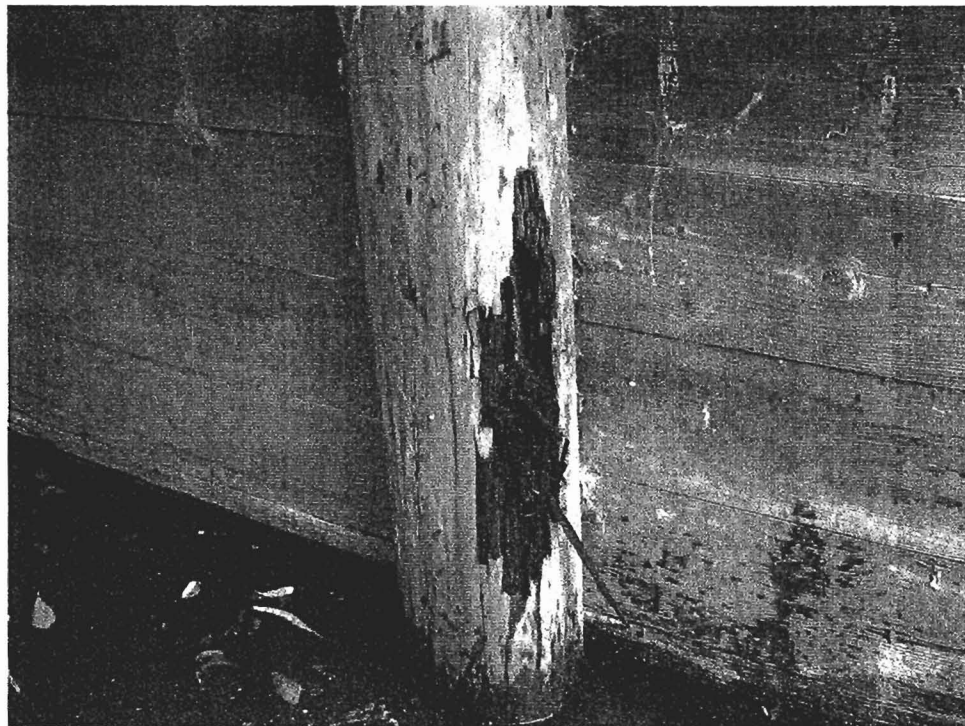
6. Pile 1 at the West Abutment has a 6" deep area of decay for the full height of the north face (see Photo 14). Pile 3 has 9" high x ½" deep area of decay for the full circumference at the waterline.

Photo 14 – Pile 1 at the West Abutment.

60.14- All timber piles are soft at the surface with 1/2" pick penetrations. Pile 1 at the West Abutment has a 6" deep area of decay for the full height of the north face. Pile 3 has a 9" high x 1/2" deep area of decay for the full circumference at the waterline. The piles at the bents had 1/2" pick penetrations and a few small areas of shallow decay. Pile 1 at the East Abutment has a 2'-0" x 1'-0" x 1" deep area of decay on the west face at the waterline. Pile 2 has a 1'-0" x 9" wide x 1" deep area of decay on the south face at the waterline.
